PROBLEMS ENCOUNTERED DURING INSTALLATION AND OPERATION  
OF A  
STORABLE PROPELLANT FACILITY  
FOR TESTING OF TITAN II COMPONENTS AND SYSTEMS

WYLE LABORATORIES

TECHNICAL NOTE

MARCH 7, 1961

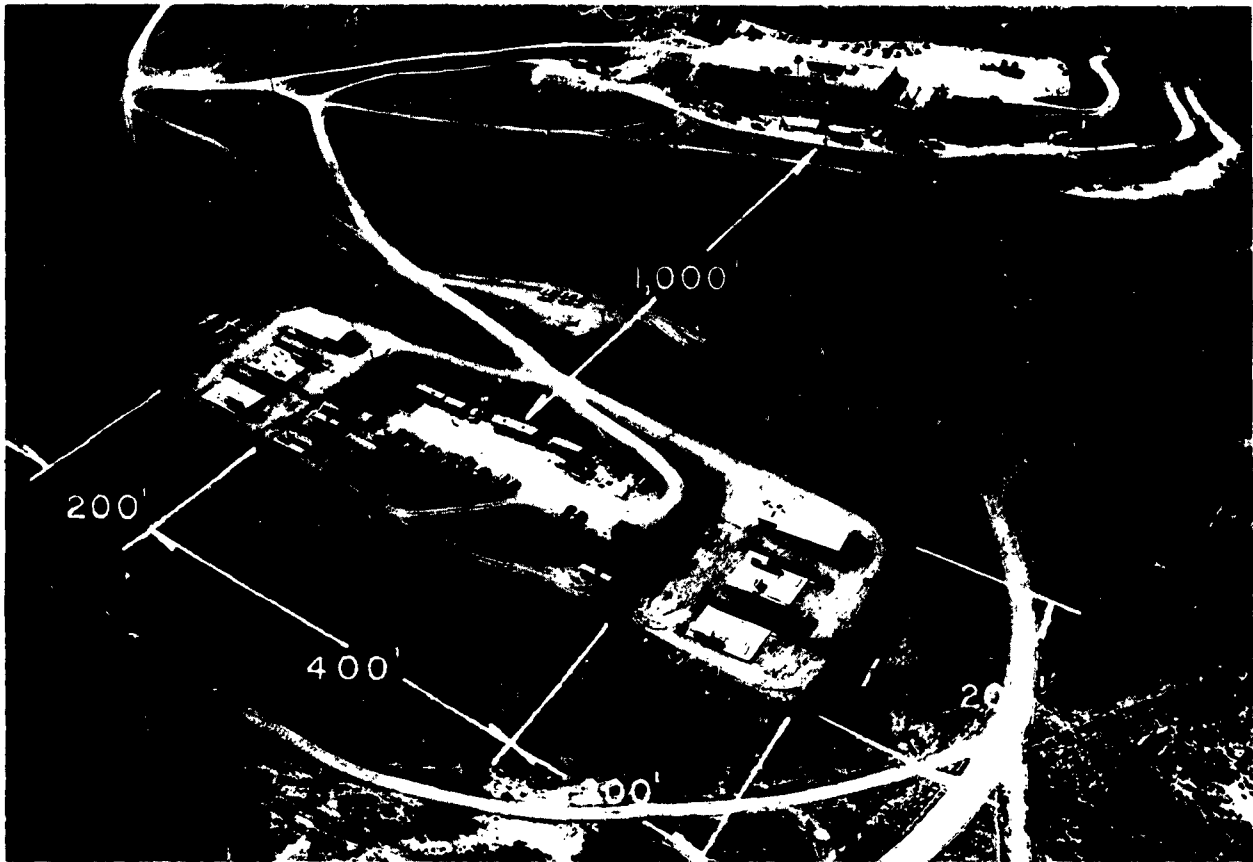
FIGURE 1

WYLE LABORATORIES STORABLE PROPELLANT FACILITY

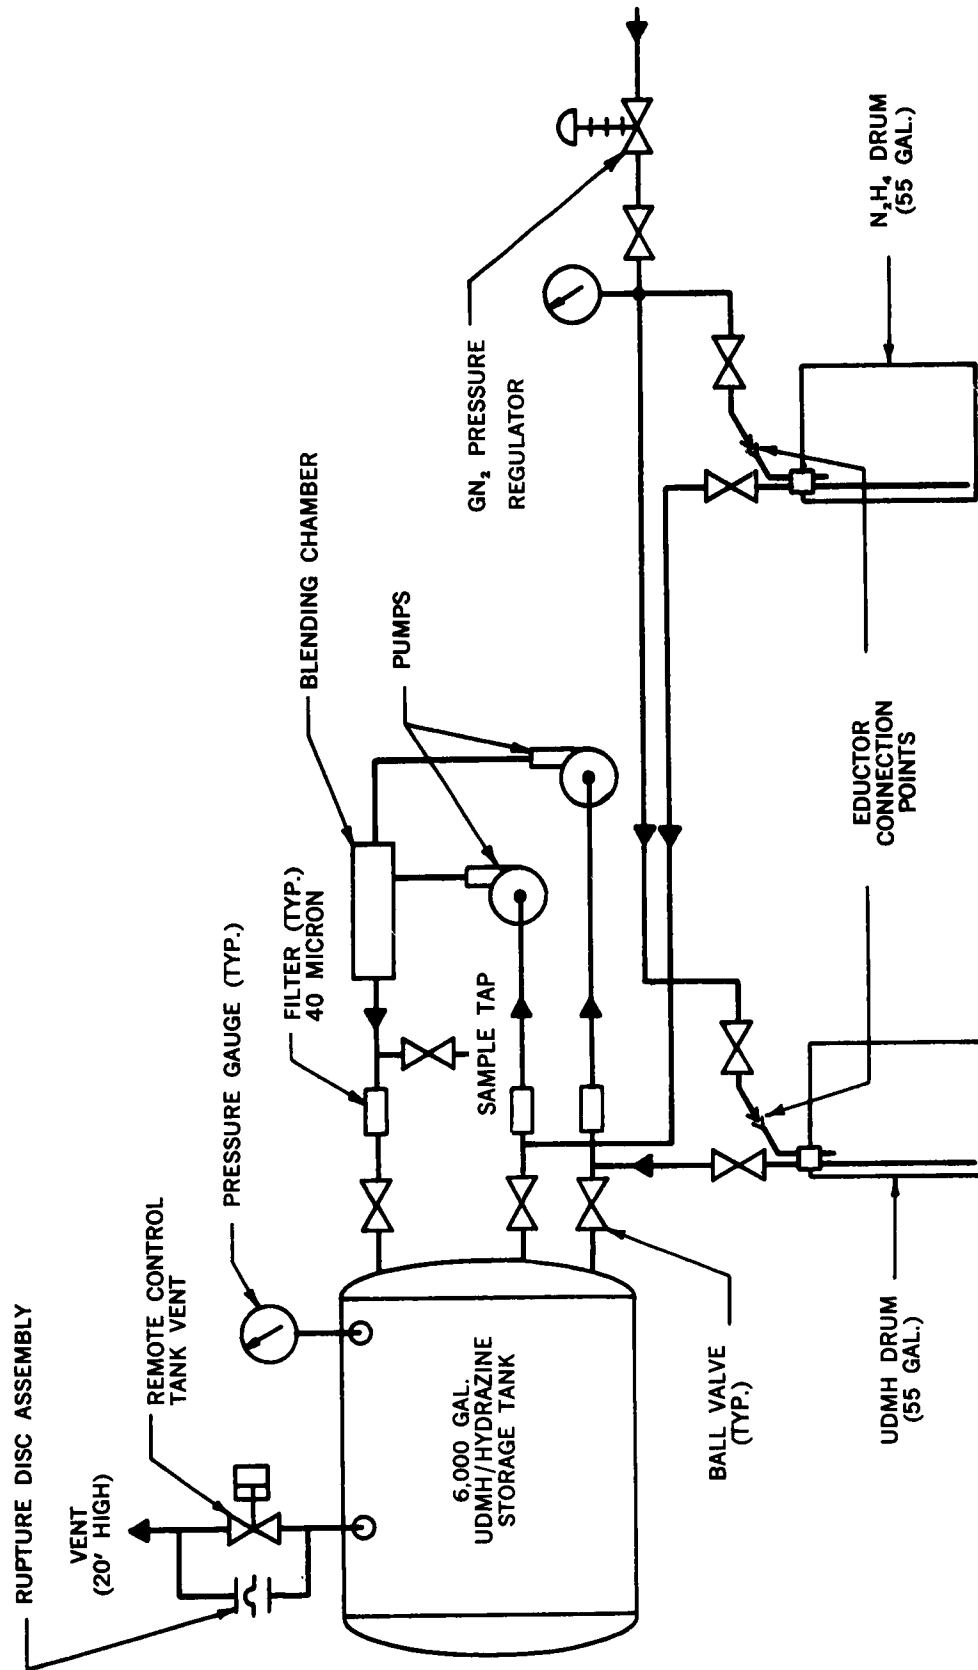
FIGURE 7  
UDMH/HYDRAZINE BLENDING SYSTEM

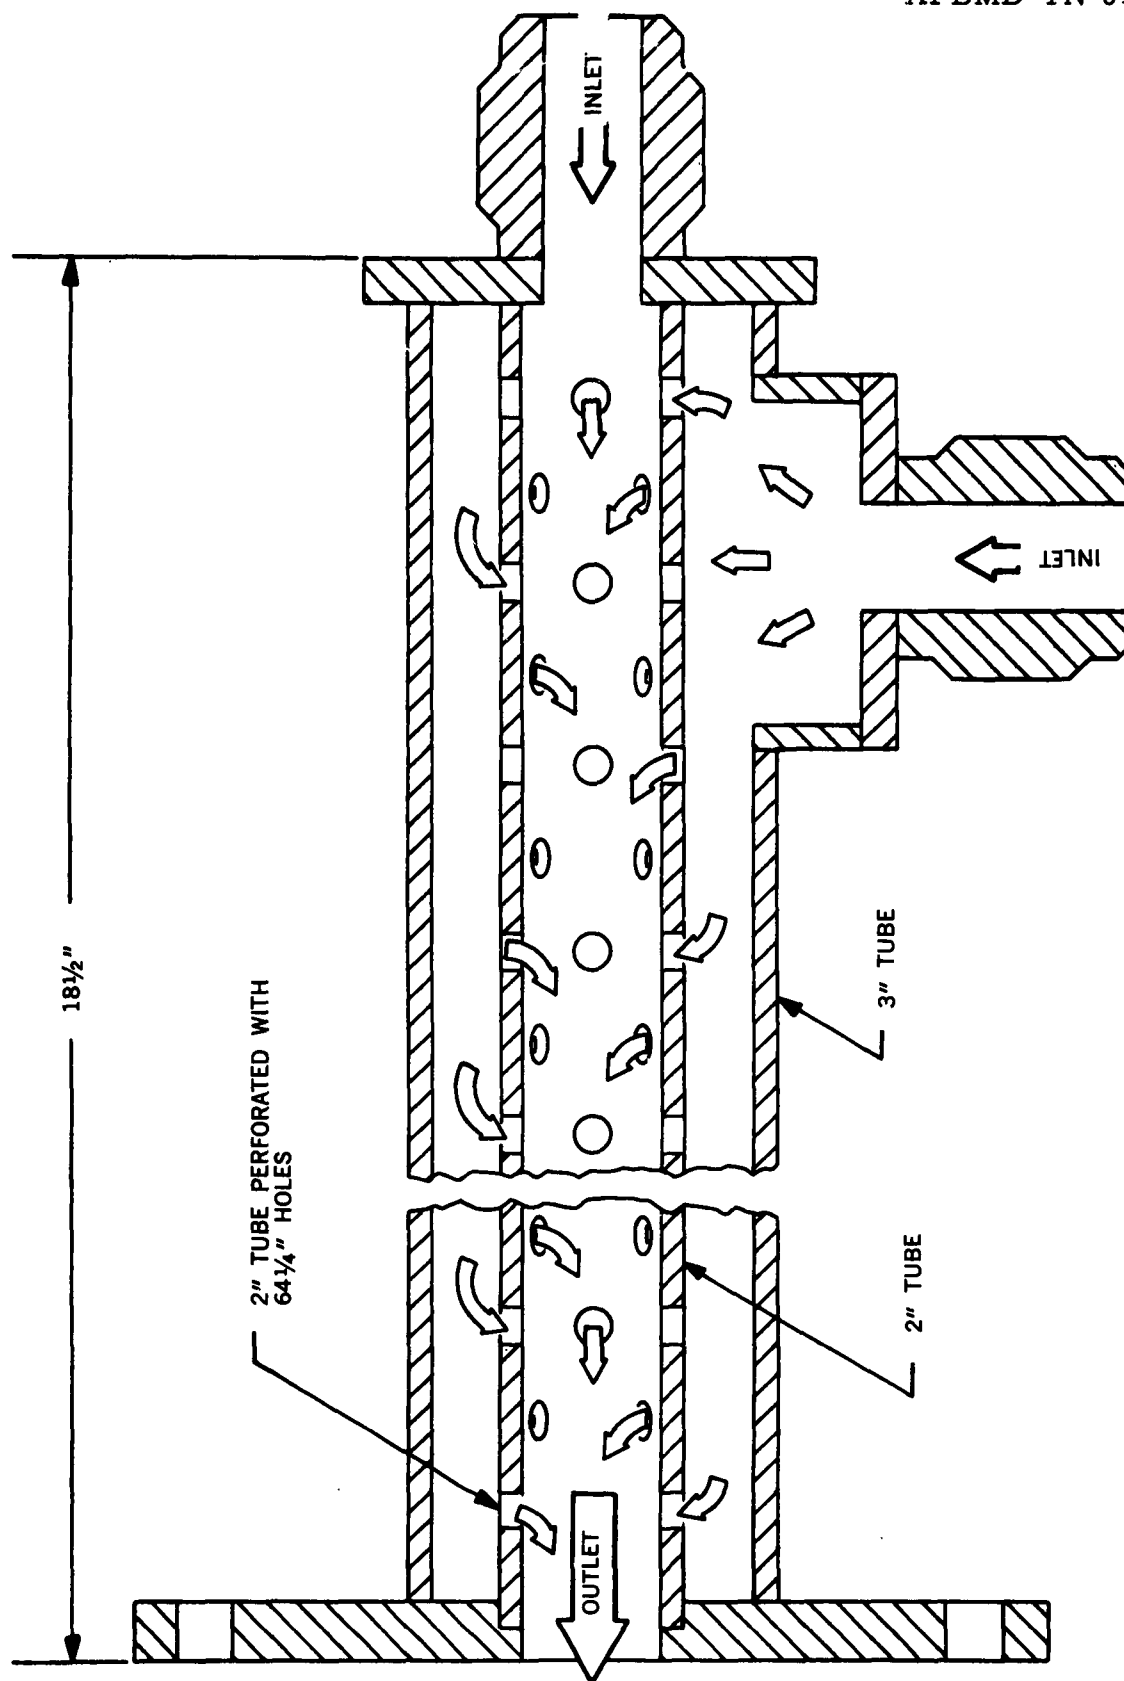
FIGURE 9

UDMH/HYDRAZINE BLENDER DETAIL

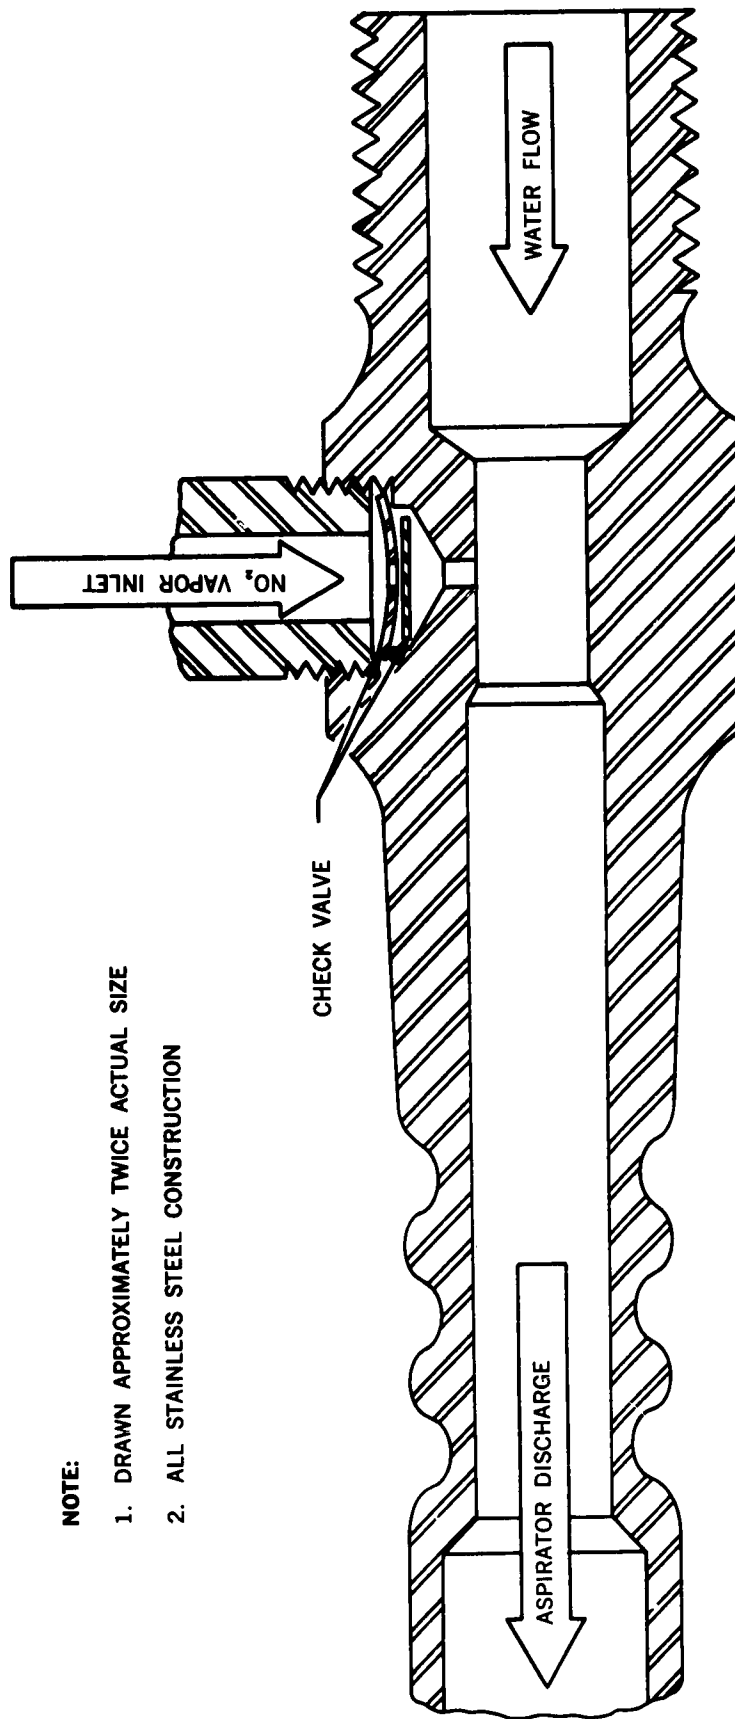
1. DRAWN APPROXIMATELY TWICE ACTUAL SIZE
2. ALL STAINLESS STEEL CONSTRUCTION

FIGURE 12  
TYPICAL NITROGEN TETROXIDE ASPIRATOR

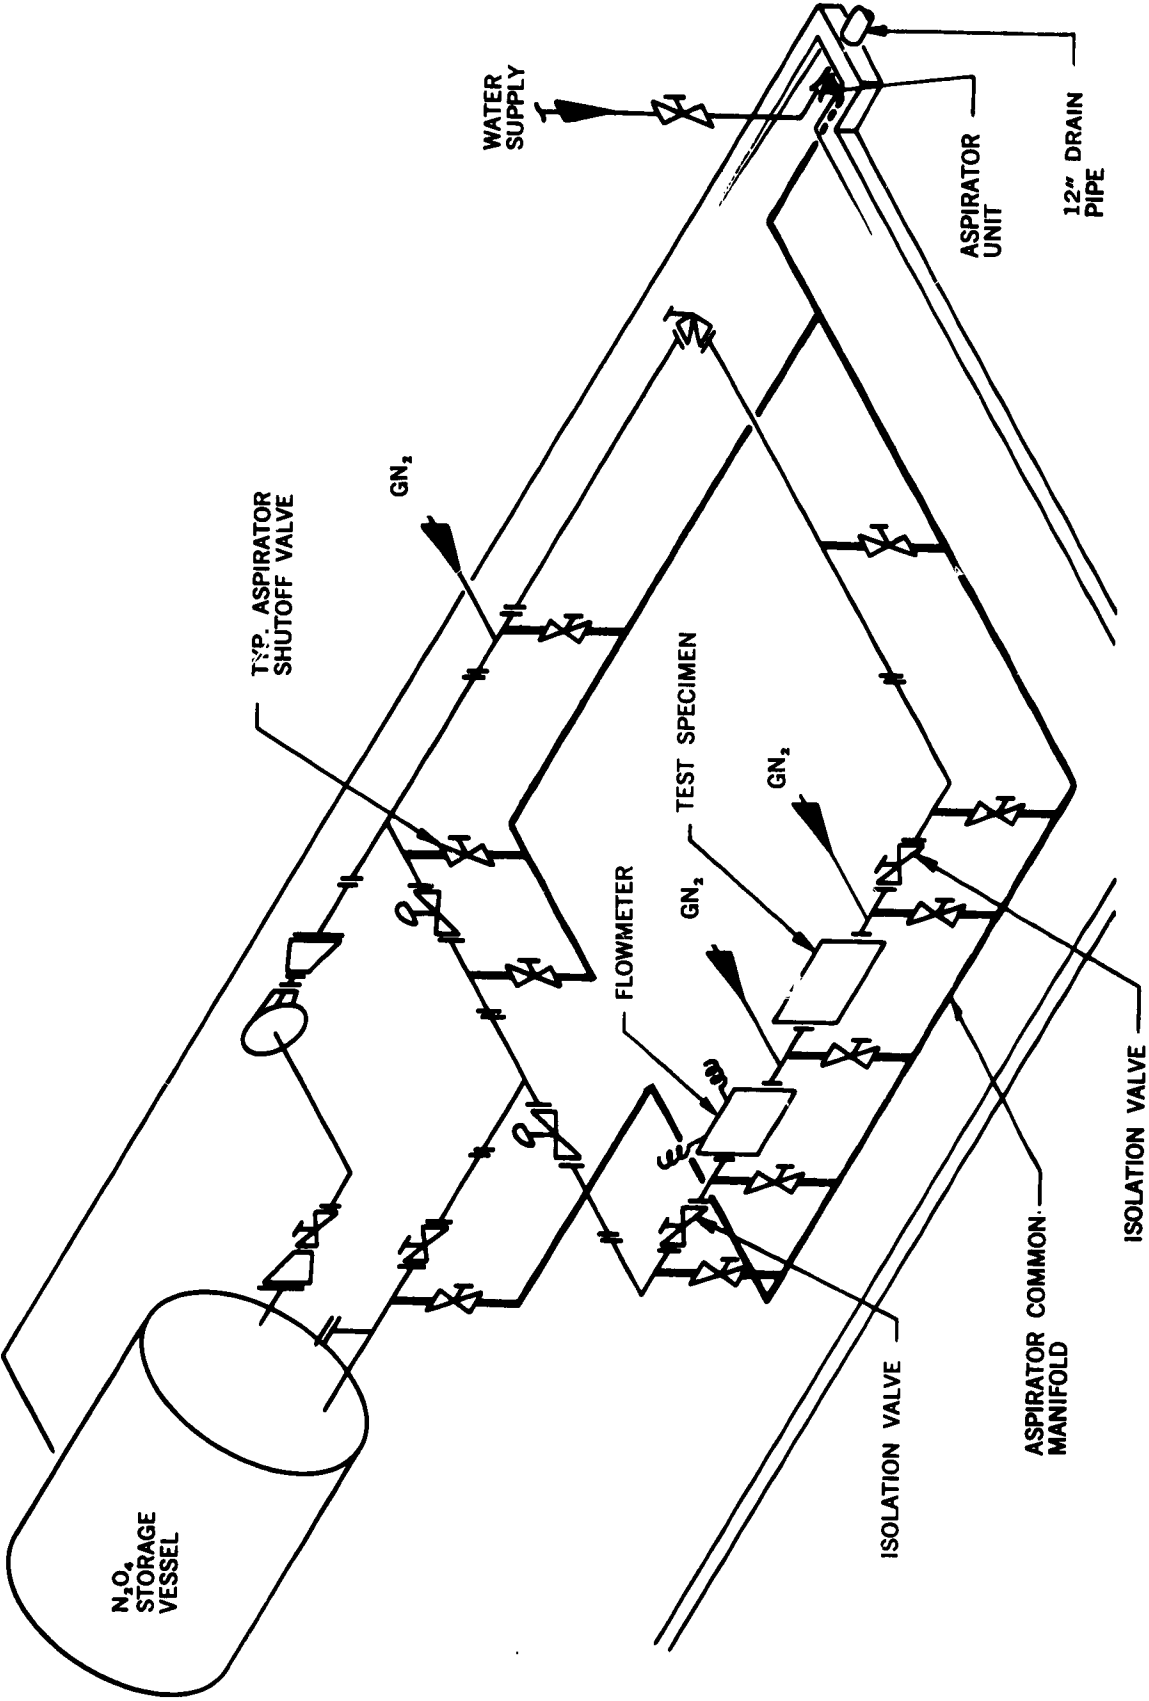
FIGURE 13  
ASPIRATION SYSTEM

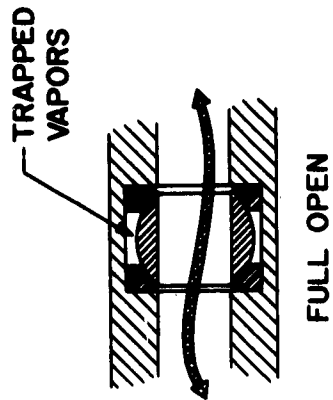
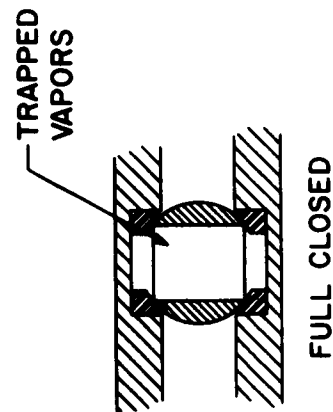
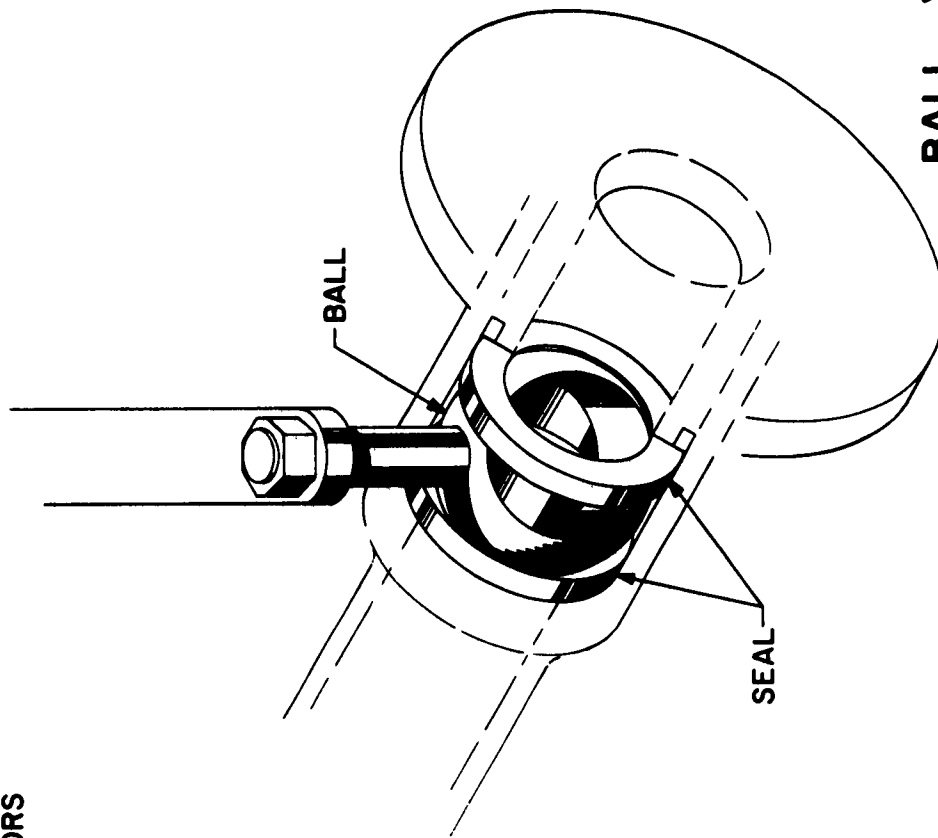
FIGURE 14  
BALL VALVE CONSTRUCTION

The ball valves were periodically operated through full travel limits while submerged in the de-ionized water. This procedure was required due to the inherent design features of this type of valve. As shown in Figure 14, typical ball valve construction permits propellants and vapors to escape from the valve in the 1/4-closed position only. It is of interest that the entrapped liquid and vapors were often released with sufficient violence to constitute a personnel hazard, although the operation was performed with the ball valve submerged.

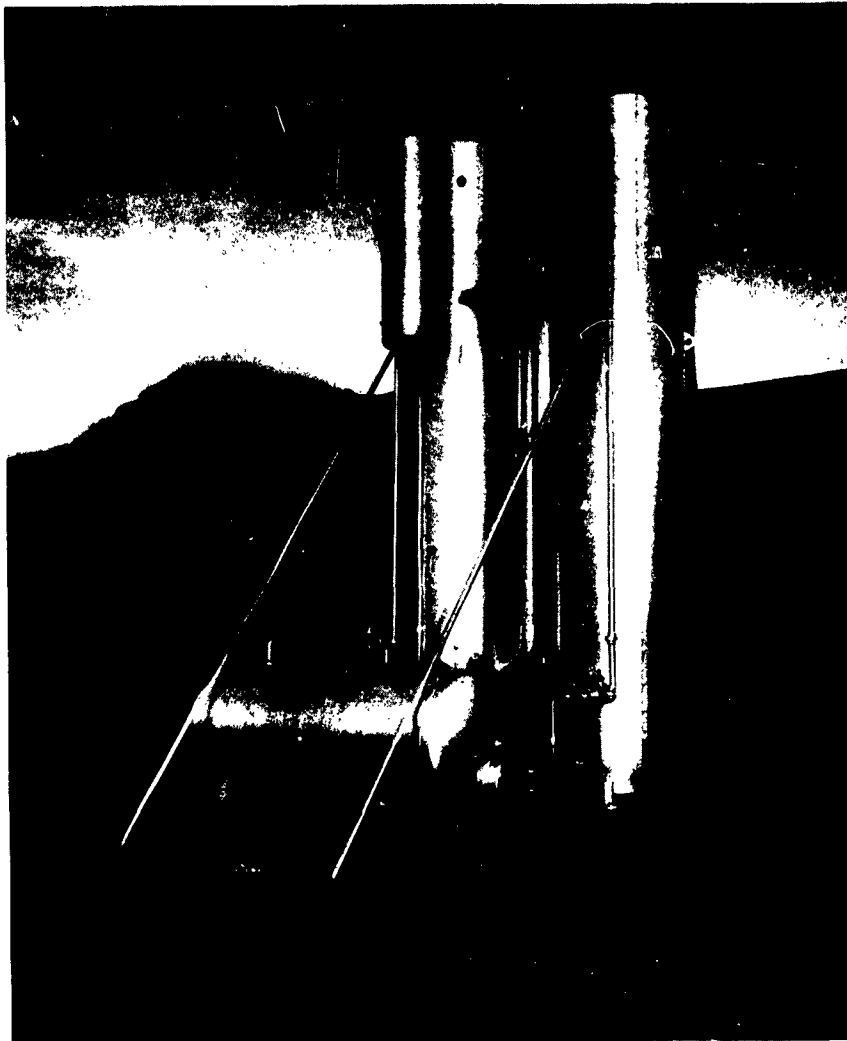
FIGURE 15

The drainage system for the nitrogen tetroxide test area was identical to that provided for the fuel blend area. A vapor scrubber was installed for scrubbing NO<sub>2</sub> vapors vented from the storage tank or other portions of the test systems. This scrubber, as illustrated in Figure 15, was a 2-stage mild steel unit which incorporated provisions for recirculating 30 gallons of 20% sodium hydroxide (NaOH) solution through each stage. As

NO<sub>2</sub> VAPOR SCRUBBER

The interior of the remaining stage was plastic coated with "Permabar" in an effort to prevent additional acid attack on the mild steel. After a few weeks of use, the second stage also developed minor leaks, possibly due to incorrect application of the coating. While the basic problem resulted from not using a compatible material (i.e., stainless steel) in the scrubber construction, there is still some doubt as to the scrubber's effectiveness.

With a highly basic solution discharging through the shower heads, the  $\text{NO}_2$  vapors were still not satisfactorily neutralized during venting operations. This condition possibly resulted from insufficient Roschig tube contact area or possibly from insufficient "contact time" for the  $\text{NO}_2$  to form  $\text{HNO}_3$  and subsequently react with the basic solution.

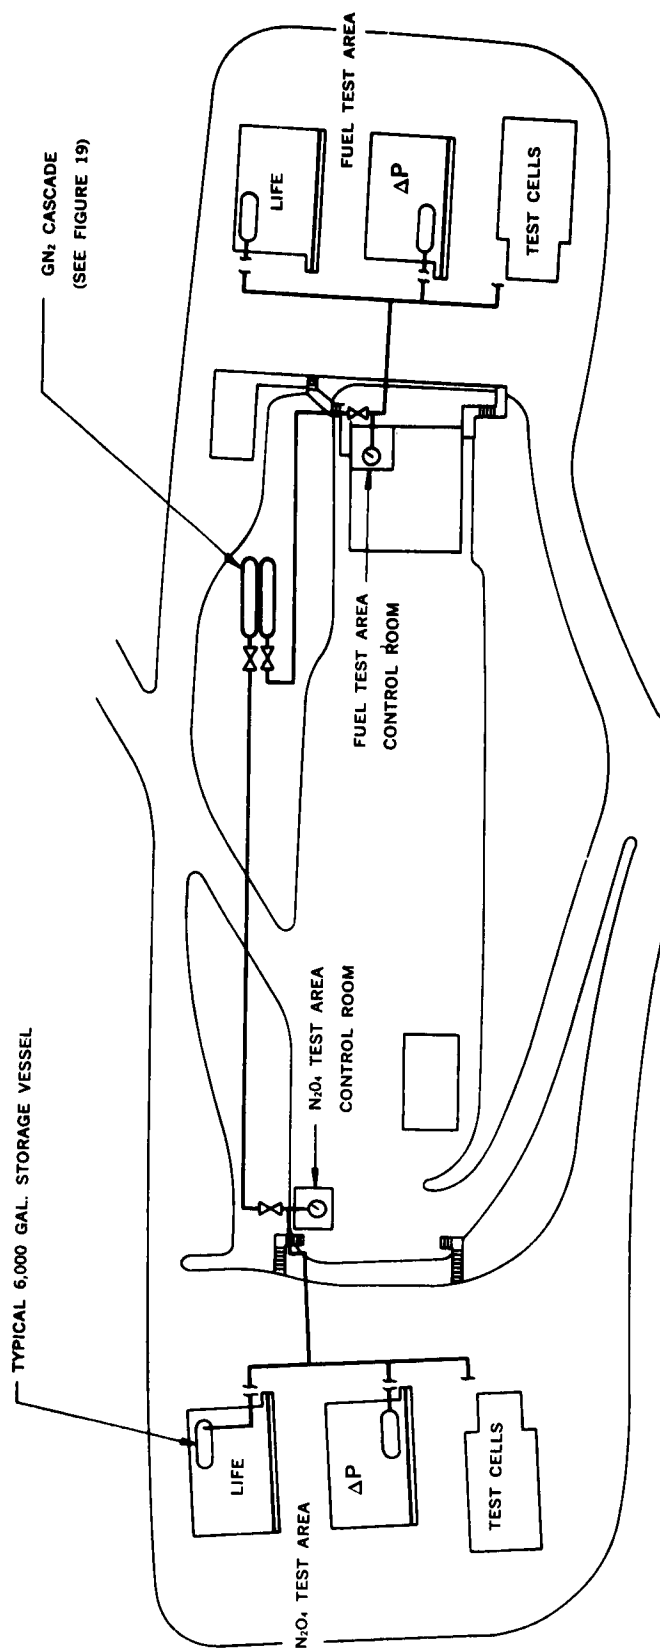
FIGURE 18

## GASEOUS NITROGEN DISTRIBUTION SYSTEM

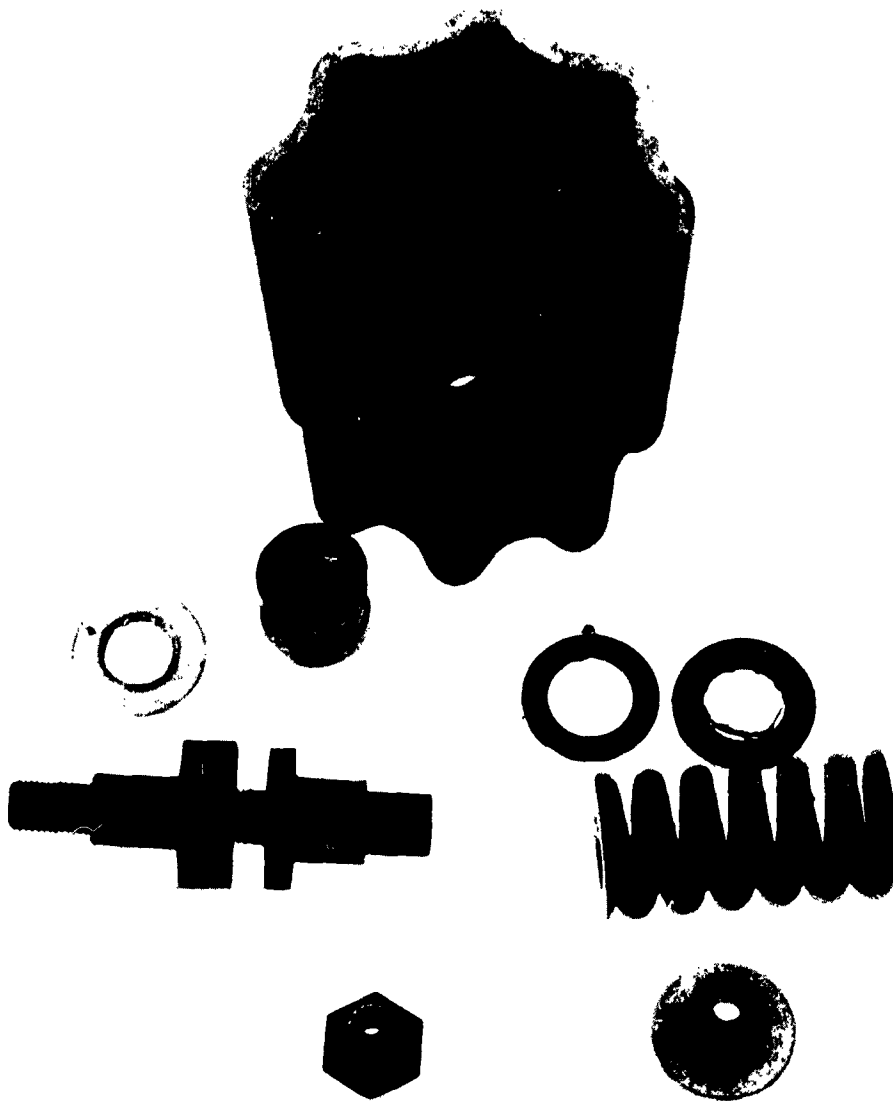
FIGURE 20

In the second instance, the NO<sub>2</sub> vapors attacked the nylon and brass portions of the Victor Equipment Company hand regulators. The results of the NO<sub>2</sub> corrosion are shown in Figure 20. Again, check valves, installed in the pressurization system downstream of the regulators, prevented recurrence of the failures.

CORRODED GN<sub>2</sub> REGULATOR

Nitrogen hand regulator which failed due to corrosive attack of NO<sub>2</sub> vapors on steel spring, bearing race, brass and nylon seats, seals, etc.

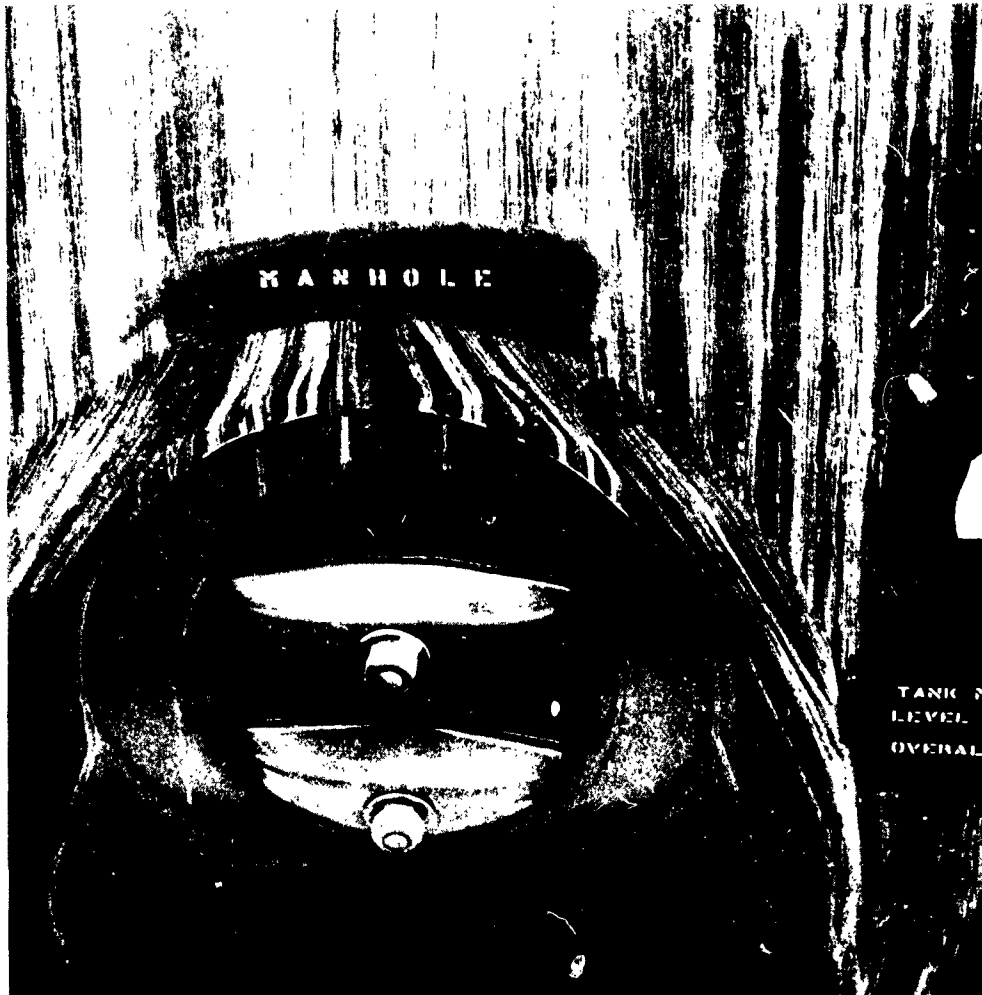
FIGURE 24

MANHOLE COVER--PROPELLANT STORAGE VESSEL

Typical manhole cover installation on 6,000 gallon propellant vessel.

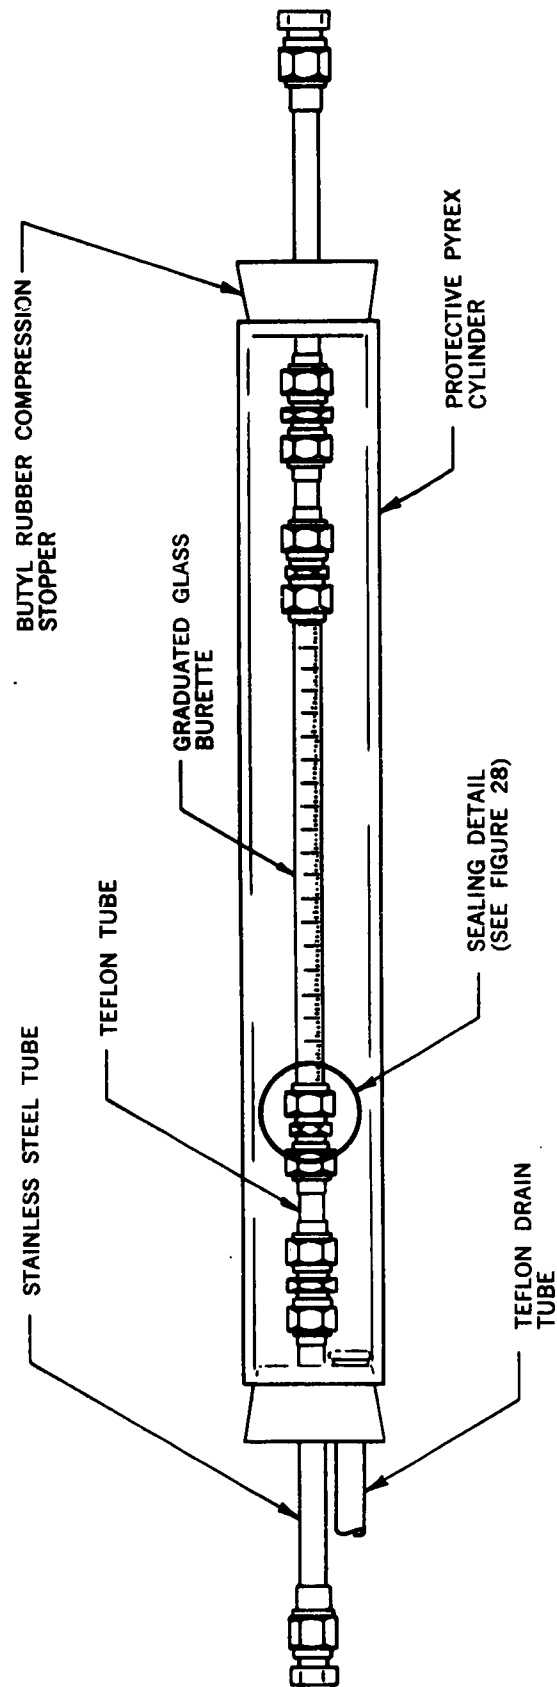
FIGURE 27  
N<sub>2</sub>O<sub>4</sub> SPECIMEN LEAKAGE INDICATOR

To preclude the possibility of failure recurrence, leakage indicators containing protective pyrex outer sealant and swage lock sealing features were installed. These indicators, as shown in Figures 27 and 28, have performed satisfactorily to date.

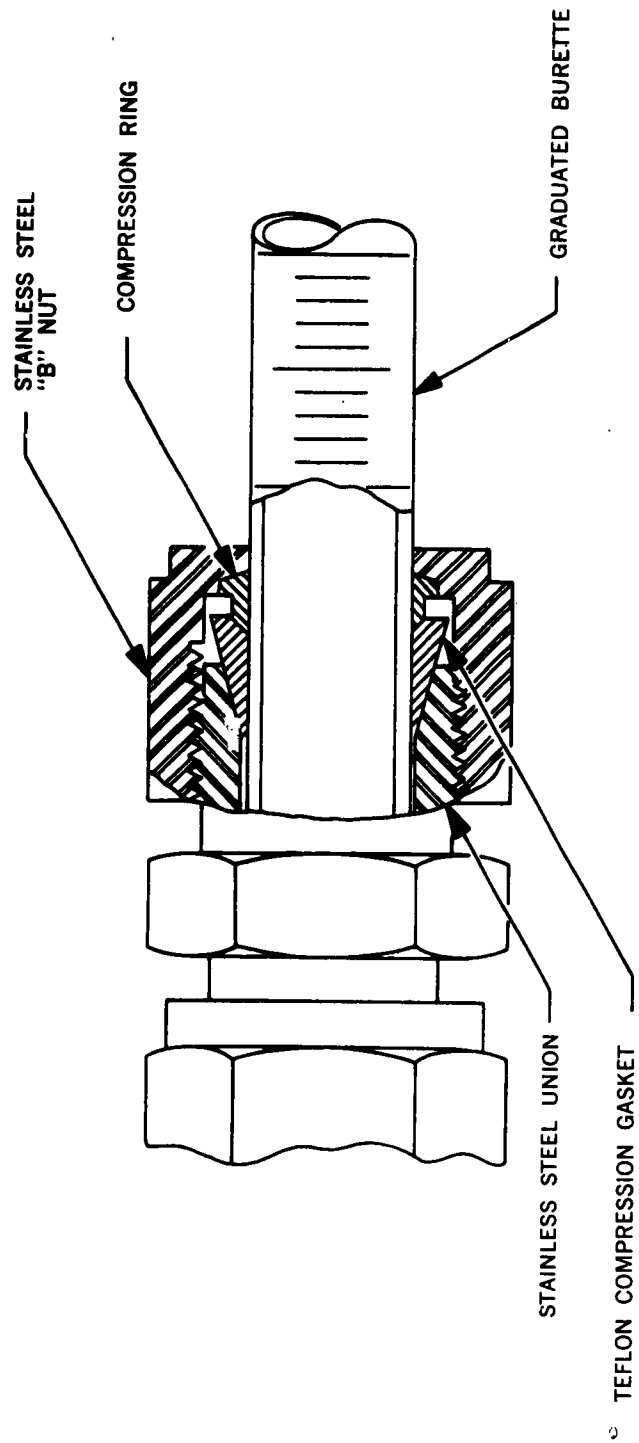
FIGURE 28

SEALING DETAIL

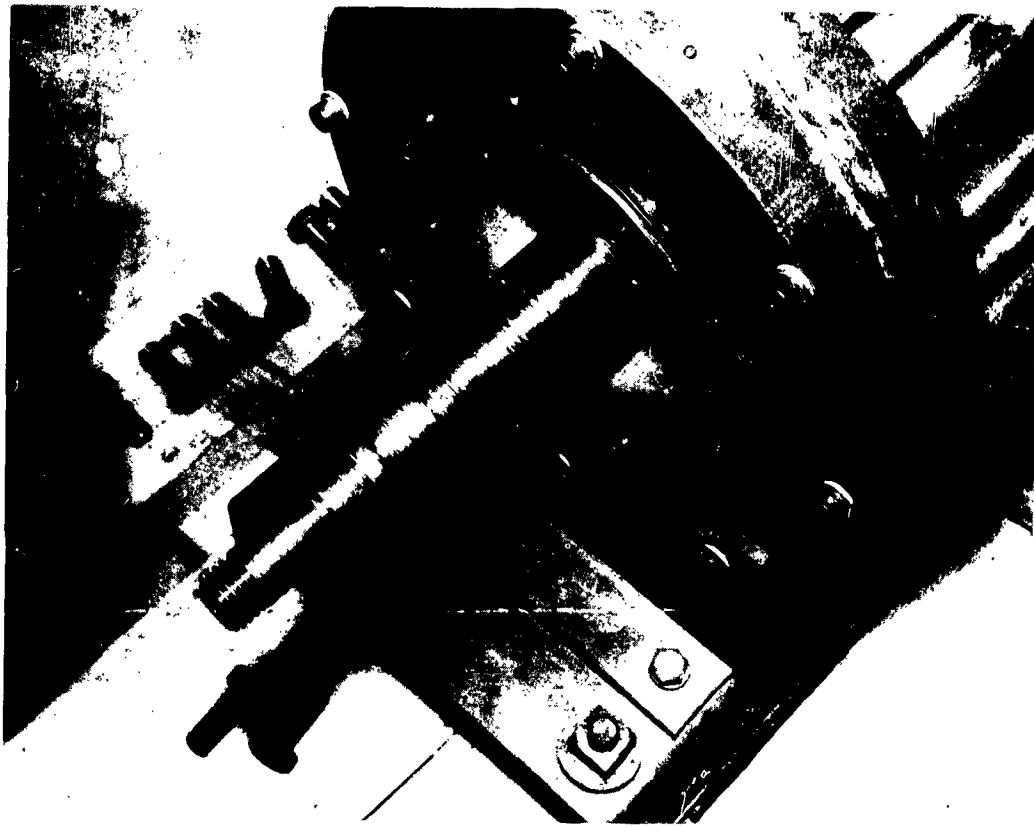
FIGURE 30

SCORED PUMP SHAFT

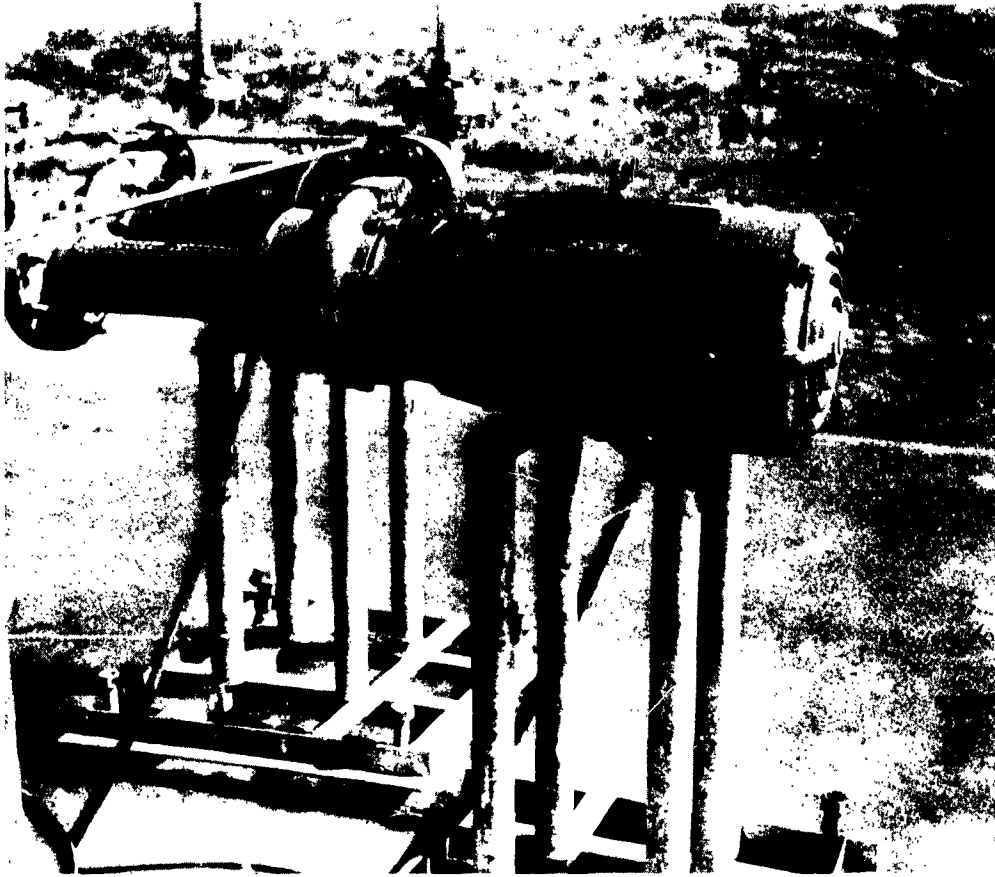
FIGURE 31

TYPICAL INCOMPATIBLE PAINT APPLICATION
